## UT32M0R500 RCCA Investigation Summary: Power Up Issue

Microelectronics Division  
Frontgrade Technologies

April 2024

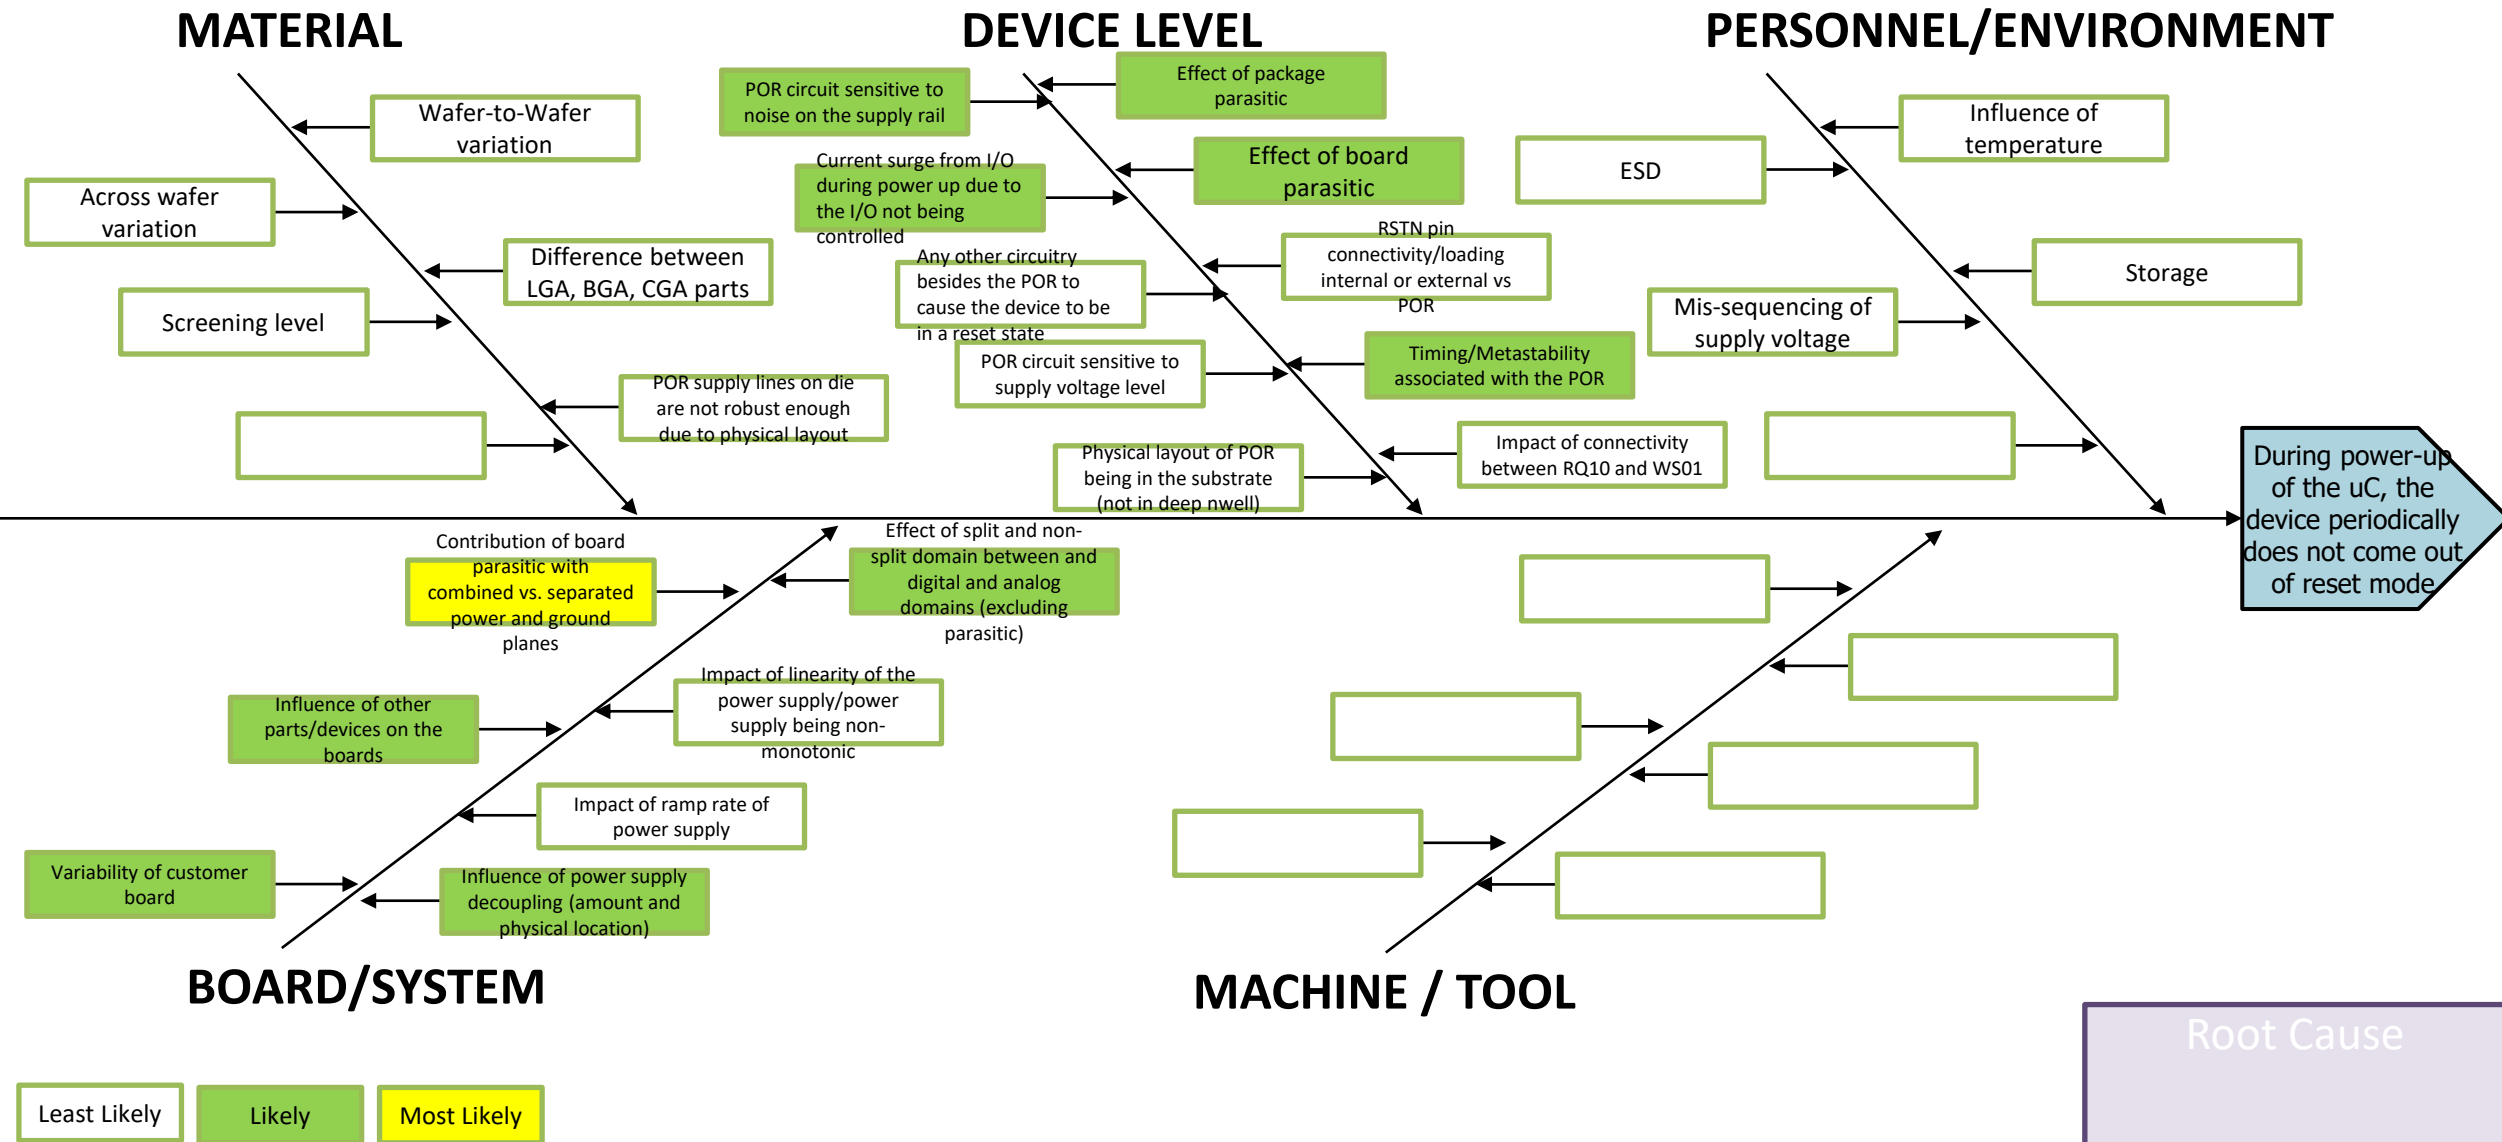
## Fishbone Diagram

Factor	Hypothesis	Likelihood	Action	Status	Notes
Device Level	POR circuit sensitive to noise on the supply rail	Likely	1. Simulation with device layout pkg and/or board parasitic	Complete	Simulations with parasitic extracted netlists of POR cell, resistance in supply connections, package wirebond model estimates. Noise added to supply voltages, repeated with LDO regulator. Added fast large glitches to supplies. No problems found, POR function OK

Factor	Hypothesis	Likelihood	Action	Status	Notes
Board/System	Contribution of board parasitic with combined vs. separated power and ground planes	Most Likely	1. Respin one of the eval boards with and without ground planes	Complete	Detailed in test section

Factor	Hypothesis	Likelihood	Action	Status	Notes
Material	Fabrication process has significant variation	Least Likely		No Action	No correlation found
	Wafer-to-Wafer variation	Least Likely		No Action	No correlation found
	Across wafer variation	Least Likely		No Action	No correlation found
	POR supply lines on die are not robust enough due to physical layout	Least Likely		No Action	
	Difference between LGA, BGA, and CGA	Least Likely		No Action	No correlation found
	Screening Level	Least Likely	1. Investigate ATE program for automatic power cycle per the program	Complete	No anomalies found in test program or hardware
Personnel/Environment	Mis-Sequencing of supply voltage causing an issue	Least Likely		No Action	
	ESD	Least Likely		No Action	
	Influence of temperature	Least Likely		No Action	Characterized
	Storage	Least Likely		No Action
